# Manhole Inspection Summary

Manhole # S23WW1005MH

Insp Date: **5/2/07 5:05 PM**

**Location** Address: **315 DEEPDENE RD**

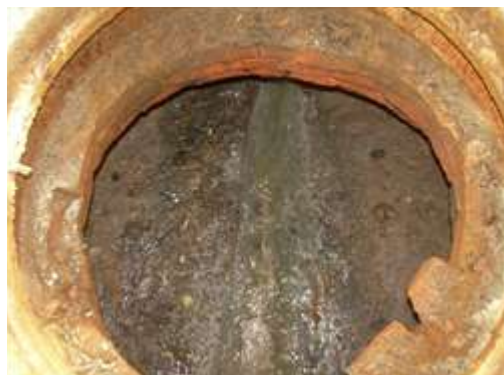
Top View

Frame leaks. Frame offset. Corbel deterioration, loose brick and infiltration.

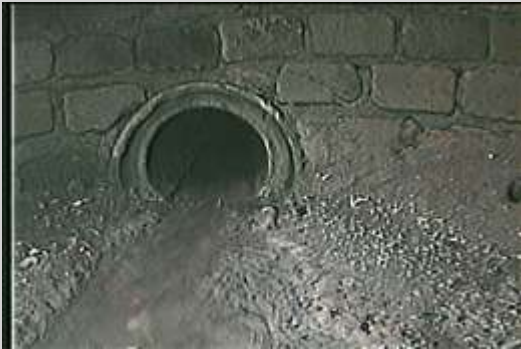
### 6 in. Circular Gravity Sewer Pipe Out @ 12 O'Clock

Infiltration: **Evidence** Pipe Seal Cond: **Cracked**

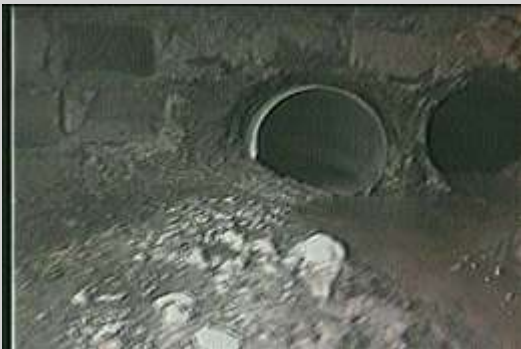
### 6 in. Circular Gravity Sewer Pipe In @ 5 O'Clock

Infiltration: **Evidence** Pipe Seal Cond: **Broken**

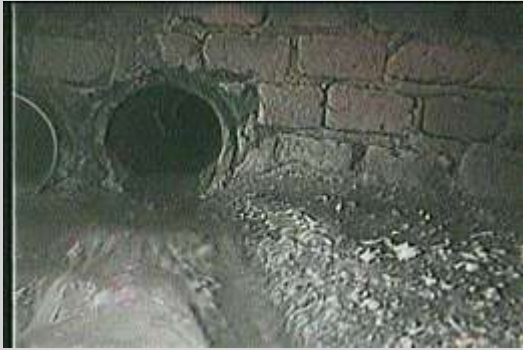
Pipe In @ 6 O'Clock

Barrel deterioration and infiltration.

Infiltration: **Evidence** Pipe Seal Cond: **Broken**
